Case study: Making a Colloide' continuous filtration plant work

Project # SP21-008

Keywords: continuous filtration, tertiary filtration, water utility, phosphorus, nutrients, Sand-Cycle

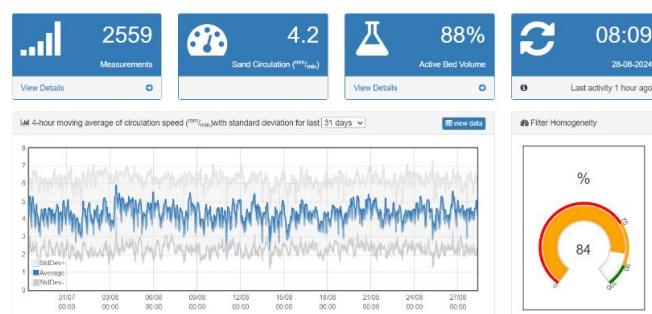
Sand-Cycle dashboard

The commissioning results were in line with our expectations. However, aiming for long-term consistent results, Sand-Cycle monitoring and control proved to be powerful to manage that. The remote monitoring allows both the process operators and us to regularly check the crucial filter system parameters. Consistent sand circulation rates, homogeneous sand movement and sand volume are monitored and visualized in dashboards. Whenever an anomaly is detected, a rapid intervention prevents deterioration of the filter performance.
